# CAUSE AND EFFECT

## Mandrel Drives Are Not All Created Equal

## TECH ► MANDREL DRIVES

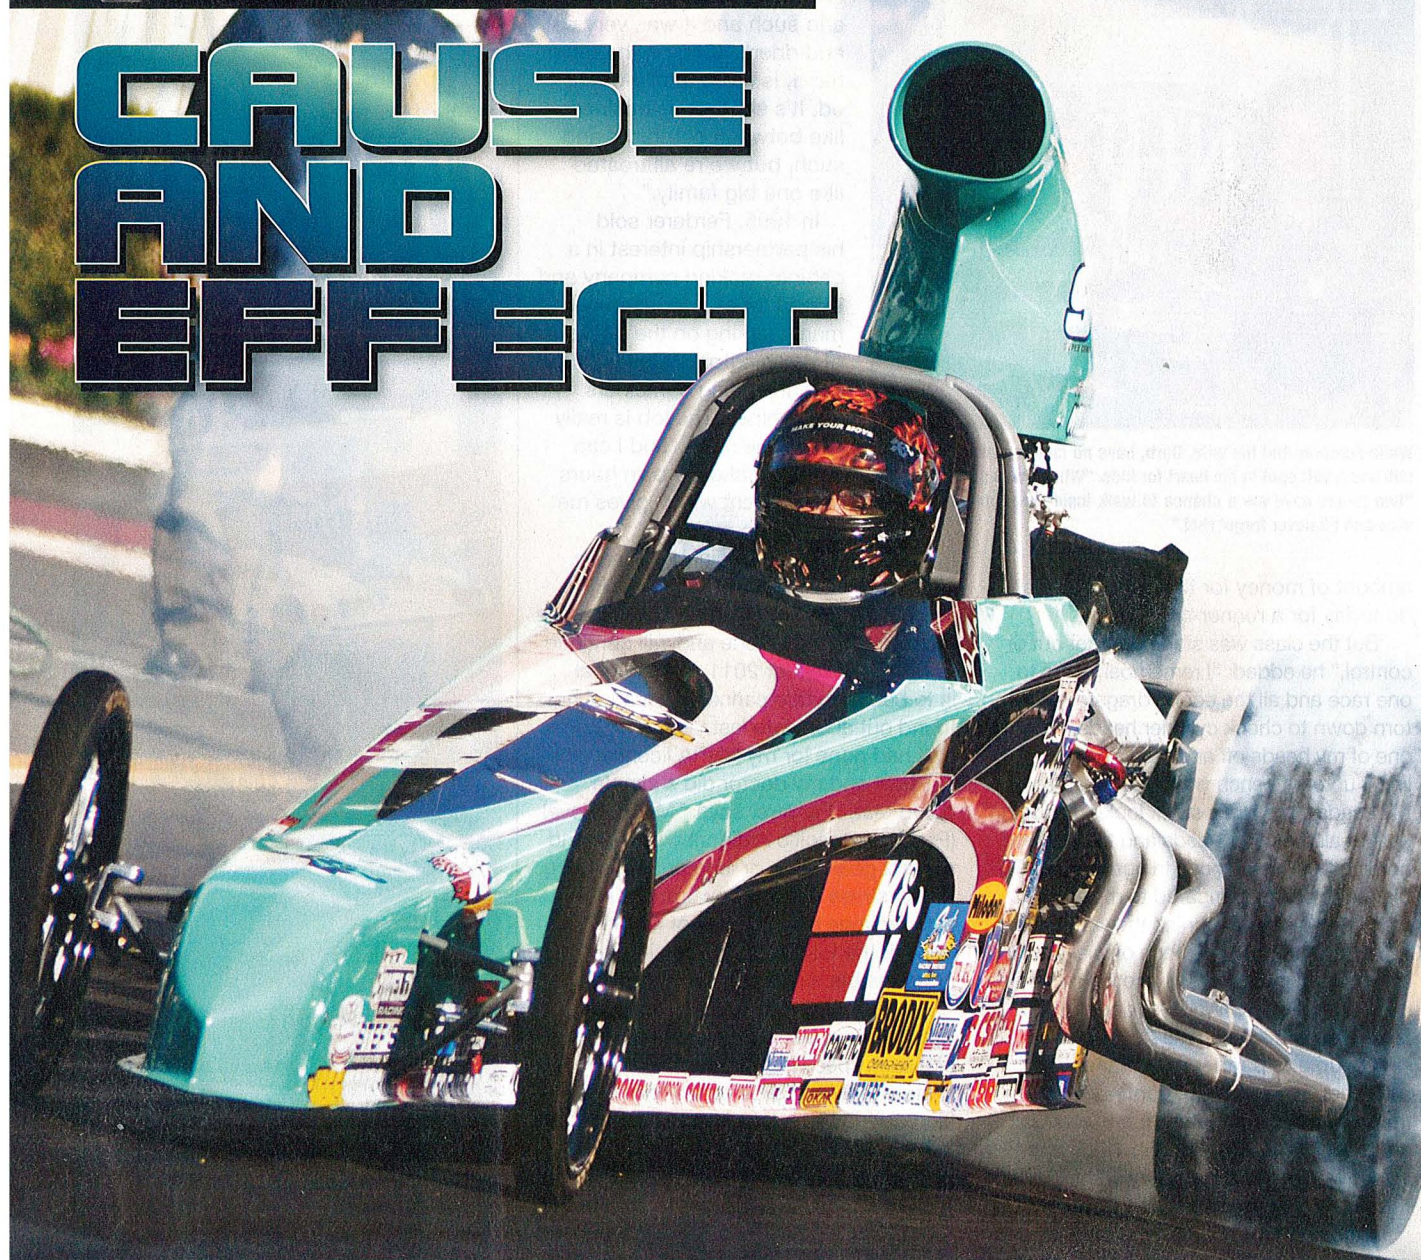
This is the arrangement we previously used to drive the vacuum pump, alternator and mechanical fuel pump on one of our Project Engines.

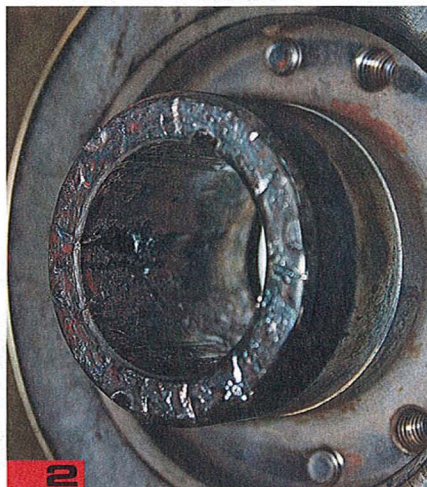
...And this is the damage it caused to the harmonic damper hub alone, let alone the damage to the crankshaft snout.

type of set-up can impart on the damper hub and crankshaft snout. It took quite a bit of heat and two broken damper pullers just to get the damper removed from the crankshaft. The end result was both a damaged damper and crankshaft with those components requiring return to their respective manufacturers for proper repair.

J.C. Beattie of ATI Performance Products said, "The center damper bolt was only intended to hold the damper in place, not to be the basis for driving extra pulleys. That long stud will stretch when torqued and loosen up which causes the damper to move around on the crankshaft snout regardless of how tight the press fit was to start with."

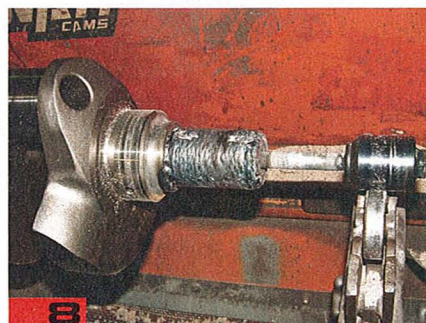
With the snout all welded up, it's time to once again straighten the crank before it's reinstalled in the lathe to grind the snout back down to its finished size.

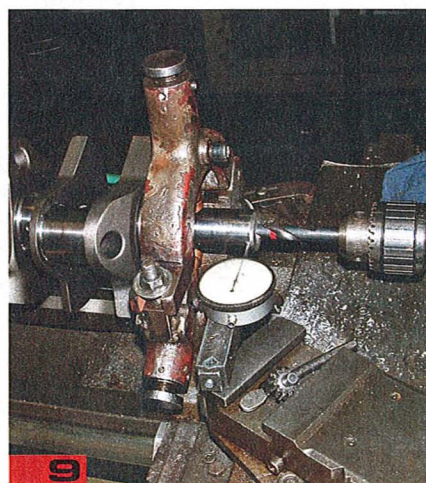
With the snout finish ground to size, Lunati deep drilled the snout to allow the damper bolt to distribute the load between the first main and the snout. This requires an extra long damper bolt but is a move in the right direction.

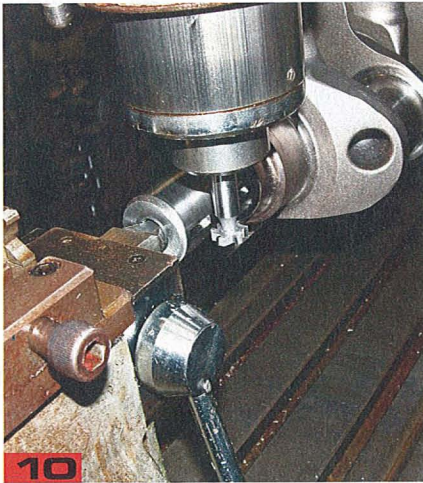
The final step to the crankshaft is to cut the grooves for the woodruff keys that locate the crank timing gear and damper, again check for straightness and finally polish the journals.

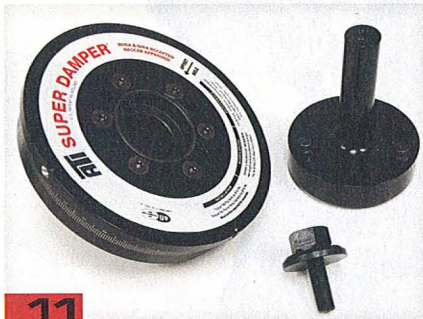
While the crankshaft was at Lunati for its repair, ATI Performance Products was repairing our damper which included the addition of an outer damper ring with the ignition magnets built right into the shell. In addition their drive mandrel mounts to the three tapped holes in the damper hub for a more precise mounting arrangement for our drive pulleys.

Beattie said, "A better system is one of our drive mandrels which register to the inside recess of the front of the damper and bolt to the three threaded holes in the damper's hub. We also feel it's better to

utilize our damper shell that has the ignition crank trigger magnets mounted right inside it which eliminates having to mount another thing to the front of the damper."

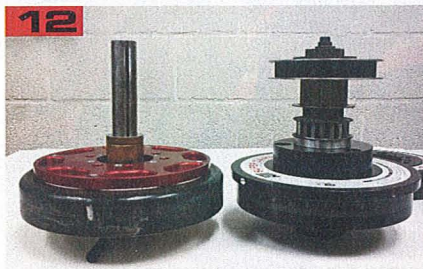
The finished mandrel and pulley system on the right will do a much better job of driving our accessories run after run without the concern of damaging a crankshaft and/or the harmonic damper.
